20 A Slaughterhouse Pavilion Becomes an Architectural Library in Rome

Abstract: Pavilion 9E is part of a significant industrial archaeological slaughterhouse complex in Rome, dating back to the end of the 19th century. The pavilion closed in 1975, was abandoned and became derelict, with the roof collapsing and leaving the structure in a precarious state. Today, part of the complex has been transformed for use by the Faculty of Architecture of the Università degli Studi Roma Tre/Roma Tre University for its library. The goal of the project was to restore and convert the building for a new public use maintaining a delicate balance between intervention and preservation. The renovation would include both new build additions featuring different elements or materials and restoration of some of the original industrial structures to support the reuse of the building for teaching purposes. The building was given a new roof which maintained the historical characteristics of the former roof; structures were conserved; and the mechanical and electrical plant was updated. The large internal spaces of the ground floor and the mezzanine were divided into various rooms or reconfigured using new fu

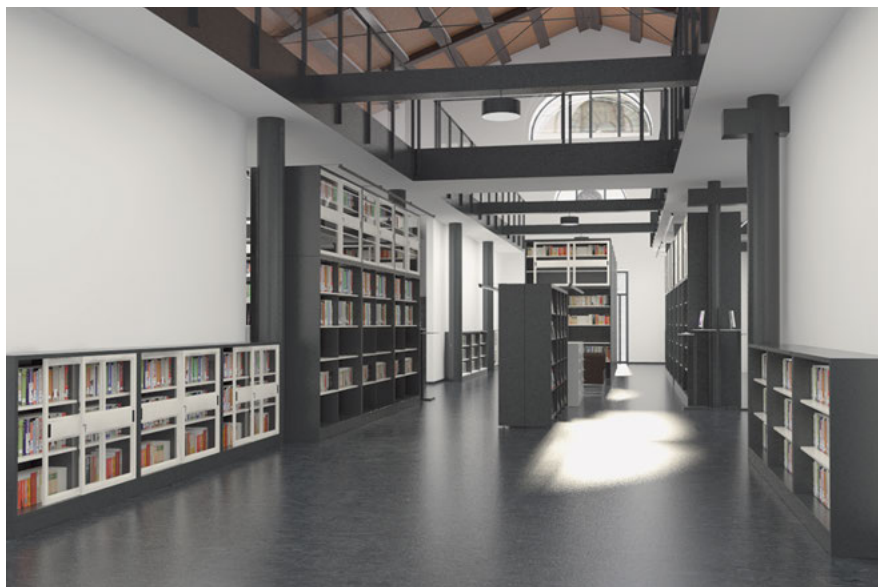
Fig. 1: The new Sezione architettura “Enrico Mattiello”. © Studio Feiffer & Raimondi.

The aim of the intervention was to respect the concept, techniques and historical value of the original structure and leave evidence of it for the future. Where possible, any measures adopted should be reversible so that any additions could be removed and replaced should new techniques become available. This approach was adopted for all new work required to change Pavilion 9E from a slaughterhouse to a library. The restoration and reintegration of details and features respect the original materials, archaeological evidence, original design and original plans. The reuse project has been mainly influenced by the industrial architectural style of the complex and its archaeological characteristics. The post-and-beam construction has defined several new areas, differentiating peripheral areas and corridors from closed areas and offices (Figures 1 and 9).

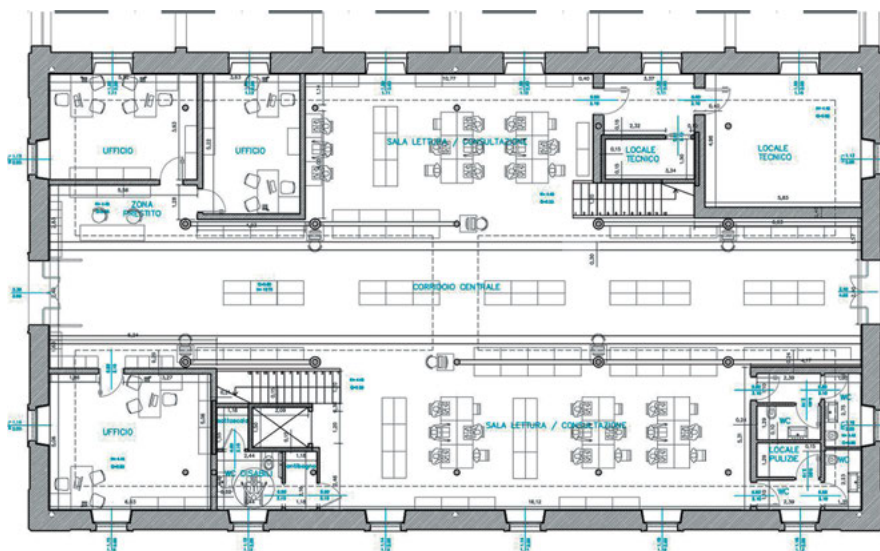
Fig. 2: Ground floor plan with the layout of workstations arranged to solve spatial, functional and technological problems. © Studio Feiffer & Raimondi.

All power and data supplies and cables are in cavities under the floor and the wiring connects directly to the furniture, to provide functional reading areas and workstations with no loose or trailing cables on the floor (Figures 2 and 12).

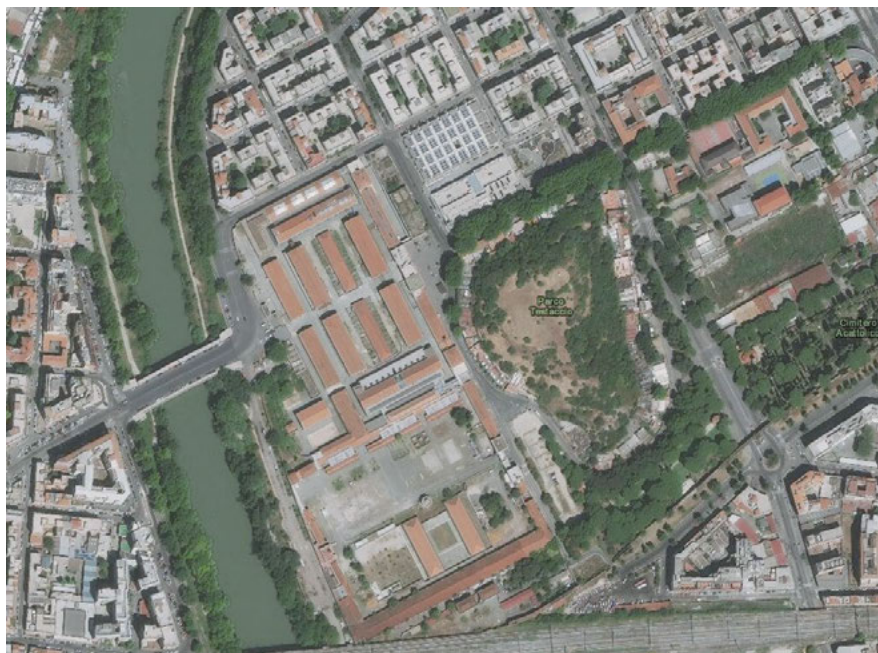
Fig. 3: An aerial view of the Mattatoio di Testaccio complex. © Geoportale, Municipality of Rome.

The restoration of Pavilion 9E of the disused slaughterhouse complex in Rome known as Mattatoio di Testaccio (Figure 3) is a clear example of adaptive reuse (Clark 2013). The complex, designed by the architect Gioacchino Ersoch, dates back to the end of the 19th century and constitutes a significant industrial archaeological site. The former slaughterhouse occupies an area of about 25,000 m², surrounding Lungotevere Testaccio and via Beniamino Franklin. The complex is divided into different buildings, pavilions, stores and open spaces, each one with a specific use, perfectly combining design and function.

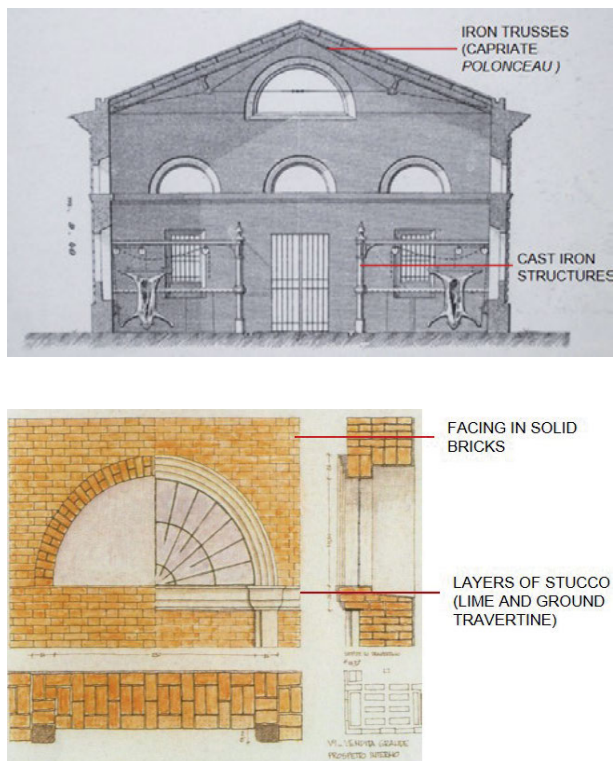
Figs. 4 A and B: Architectural and construction characteristics of Pavilion 9E. © Source: Image A: Cuppelloni 2002. Image B: Cremona, Crescentini, Pentiricci, and Ronchetti 2014.

Pavilion 9E has the same architectural and construction characteristics as the other buildings in the complex: a combination of stone and ironwork, bricks and tuff structure, a type of rock made of volcanic ash, with solid bricks and natural hydraulic lime and eco-pozzolan-based mortar, a gable roof supported by iron trusses, façades with a series of regular openings and cornerstones, and ledges coated with layers of stucco with a travertine-like finish (Figure 4).

Pavilion 9E is a medium size building (32 x 18 x 13 m) located in the south of the slaughterhouse complex (Figure 4). It was decided that the architectural section library of the University would be located in it. Until its restoration, Pavilion 9E was derelict; the roof had collapsed, and it was in a precarious structural condition (Figure 5).

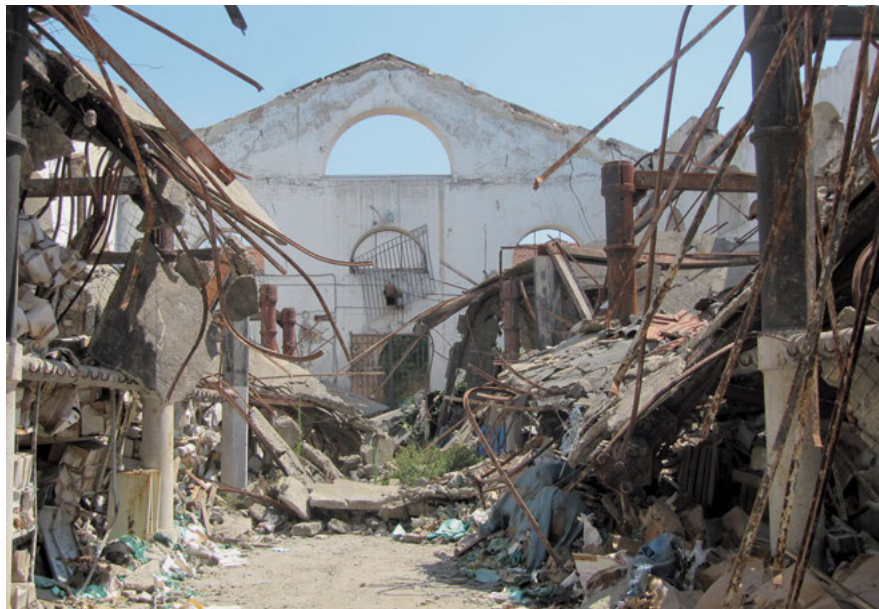
Fig. 5: The Pavilion 9E after the collapse in 2008. © Anna Raimondi.

The iron roof structure consisted of primary trusses with secondary purlins between. The trusses had a triangular profile with I-section main rafters, a tension rod lower tie and internal members consisting of struts and ties. Leakage of rainwater and corrosion caused failure of the main ties resulting in collapse of the trusses. As a consequence of the loss of the ties, the external walls, despite their substantial thickness, were incapable of resisting the resulting horizontal thrust from the main rafters and collapsed at the highest levels (Figure 5).

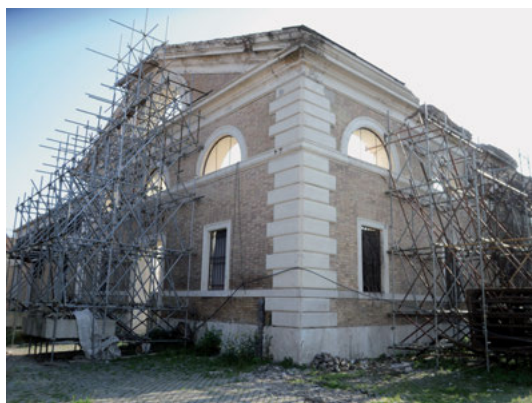
Fig. 6: The temporary constructions to stabilise structures and to ensure safety in the building site. © Anna Raimondi.

Safety on the building site and during the restoration work was of primary importance. In preparing the initial investigation programme, it was necessary to install temporary supports, to stabilise structures and to provide environmental protection (Figure 6). As part of the work, any structural fragments or archival material, such as archaeological and administrative items, were removed and safely stored in cooperation with the appropriate local and national authorities.

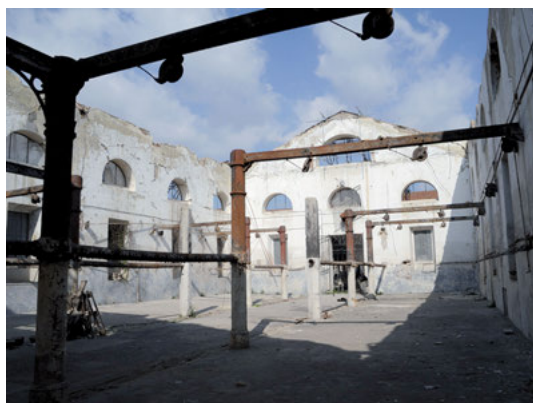
A classification was drawn up with a graphic analysis of the different types of internal and external surfaces in order to identify existing materials with each represented by a specific colour, their state of conservation indicated using a precise pattern for each form of degradation noted and registering the way restoration was to be carried out using symbols calibrated to a graphic key that described the sequence of specific restoration operations. Main actions taken included filling visible gaps in masonry with specific material or mortar, integration of missing elements including bricks, stones and plaster decorations, and conservation of metallic elements of archaeological architecture (Figure 7).

Fig. 7: Typical elements and signs of industrial archaeology that were conserved during the restoration. © Anna Raimondi.

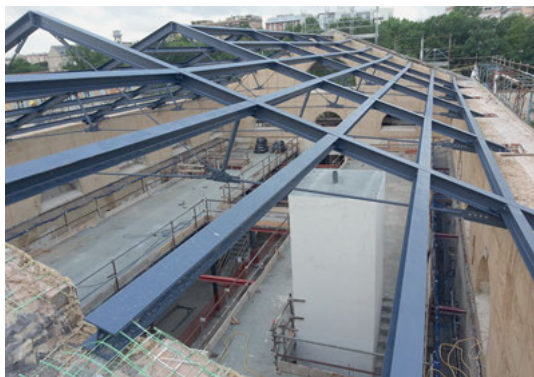
- A complete reconstruction of the gable roof and its supporting structure which was a fresh interpretation of totally damaged structural elements no longer performing their structural role. However, the design of the intervention was based on a historical image and preference was given to work that was the least invasive and most compatible with heritage values. The new roof structure is composed of five steel trusses located between windows, with struts and tie-rods, respectively beams with a HEA240 profile and elements with 40–60 mm in diameter (Figure 8).

Fig. 8: First phase of the working process for the roof construction, made of steel structures.
© Cesare Feiffer.

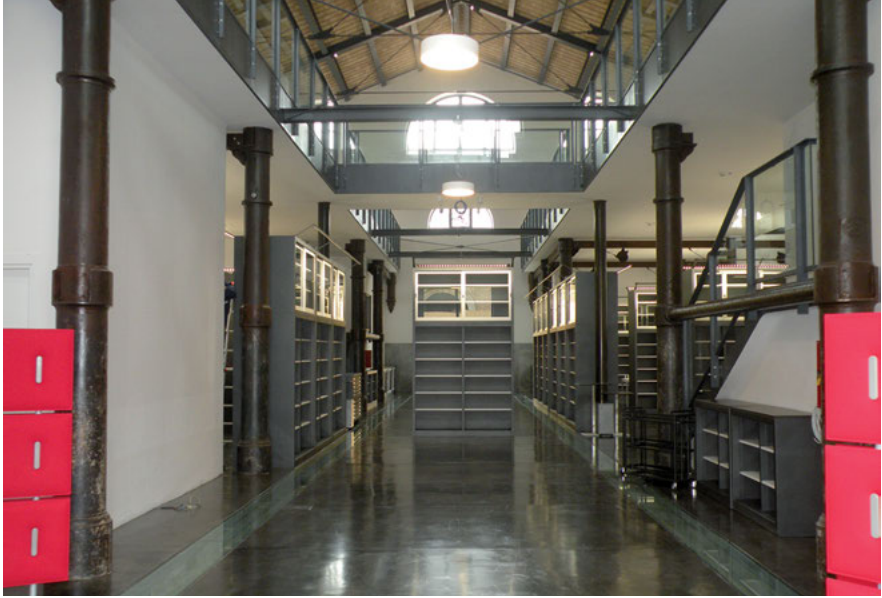
Fig. 9: Internal of the Pavilion 9E after restoration: the roof rebuilt and the iron elements as structures of the new mezzanine. © Anna Raimondi.

Inside Pavilion 9E the two levels are now used for library functions, taking advantage of the skeleton construction of the main floor and maintaining an unobstructed view of the central area on the new first floor. The new steel mezzanine is clearly distinguishable, by reference to the expression of architectural and spatial aspects (Figures 10 and 11). The plan of the internal areas has been developed through an interaction with the building, its environment, shape and orientation, defining functional zones and their connections (Figure 2). Restrooms, technical rooms and offices are located on the main level, with reading and consultation rooms on the first level. The spaces are organised as a modular internal volume, structurally independent from the rest of the building. All the new rooms are illuminated by both natural and artificial light, through large rounded arch windows, reaching to the upper floor.

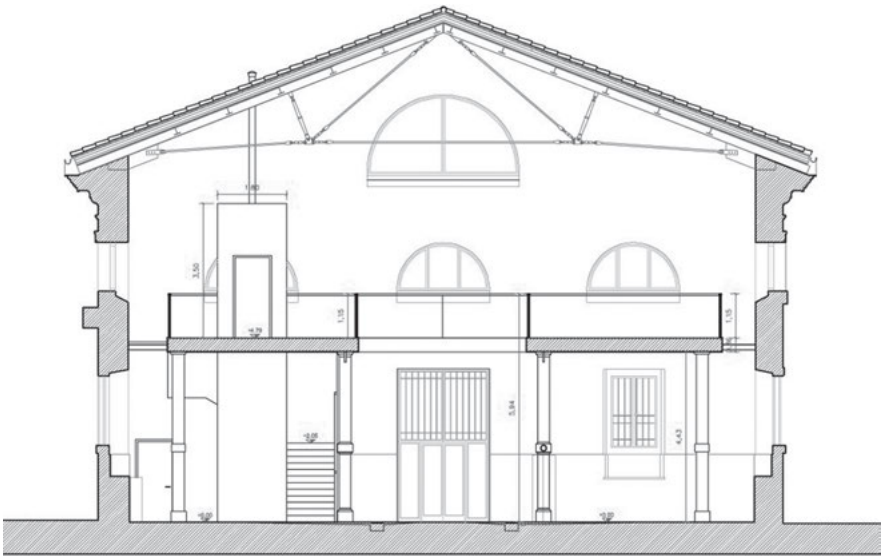
Fig. 10: A transversal section with the drawing of the mezzanine which greatly increases the usable areas. © Studio Feiffer & Raimondi.

To access the upper level, one can use either a lift or the two flights of stairs, near the central double-height hall. The open elevator shaft is contained within the pavilion, without any external construction. With the addition of the new mezzanine, the internal surface has increased by about 300 m² from 500 m² to about 800 m².

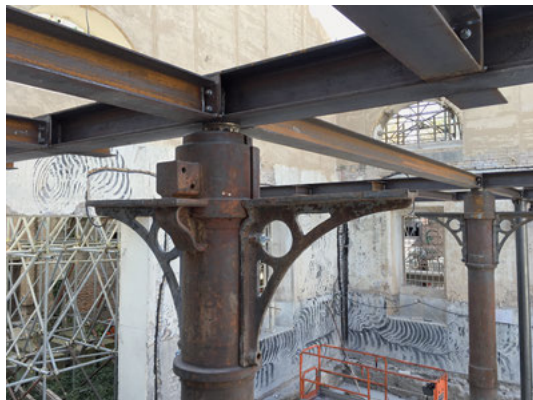
Fig. 11: Structure of the industrial archaeological elements are used as new structural elements for the new mezzanine. © Cesare Feiffer.
